Fire Testing of Concrete Beams With Fibre Reinforced Plastic Rebar

A. Abbasi and P.J. Hogg

Queen Mary, University of London, Department of Materials, London E1 4NS

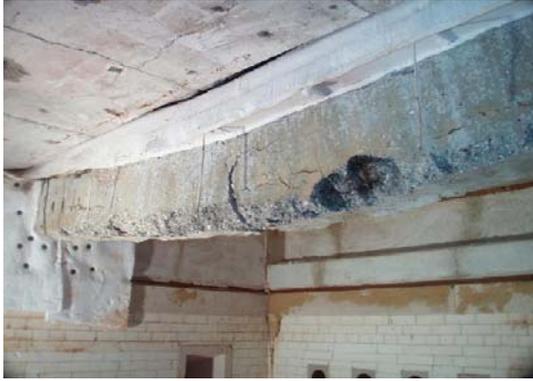
Fig 8 Rupture at the mid centre of the concrete in beam 1 after fire test

after about 75-80 minutes which was accompanied by flaming from the crack regions. The beams exhibit a suitable increase in deflection which was identified as failure after 94 minutes for beam 2 and 128 minutes for beam 1. The appearance of the beams after failure and cooling to room temperature is shown in Figure 8 and Figure 9. The mode of failure of beam is via flexural-shear cracks and spalling of the concrete. After the fire testing the beam were removed from the furnace. It was observed that beam 1 was splitting in two.

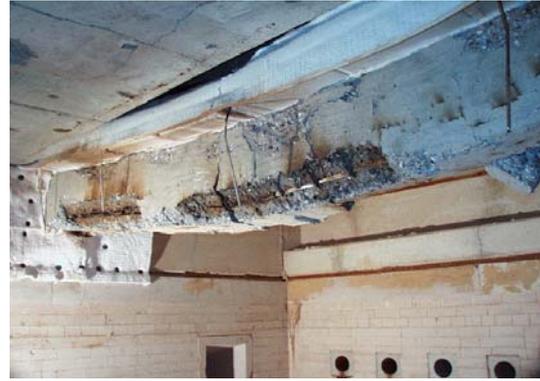
Fig 9 Failure of beam 2 after fire test inside the furnace shows some flexural cracks and rupture in the main reinforcement
